How to do

Teleservice TSA-II Modem from Siemens on VIPA 100V, 200V, 300V

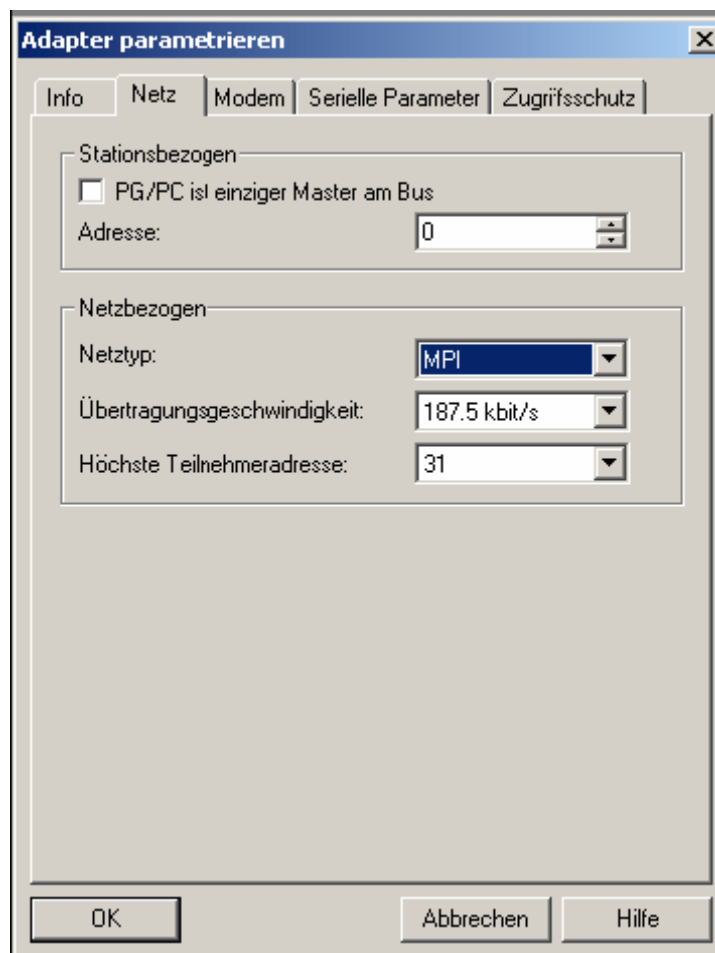
The Teleservice TSA-II Modem from Siemens is actually not supported by CPU´s 100 V, 200V and 300V. Version Date 12.12.2006, Firmware: V3.87

Reason: These CPU´s don´t support the MPI auto protocol.

Solution: MPI-settings of the TSA-II modem
switch baudrate of MPI to 187,5 kBit/s

Change in Teleservice-Software: Menu: Extra

- adapter- settings
 - o net-typ: MPI
 - o Baudrate: 187,5 kbit/s
